# **Middle Creek Watershed Assessment**

A Document of the Middle Creek Coordinated Resource Management and Planning  
Group

February 2010

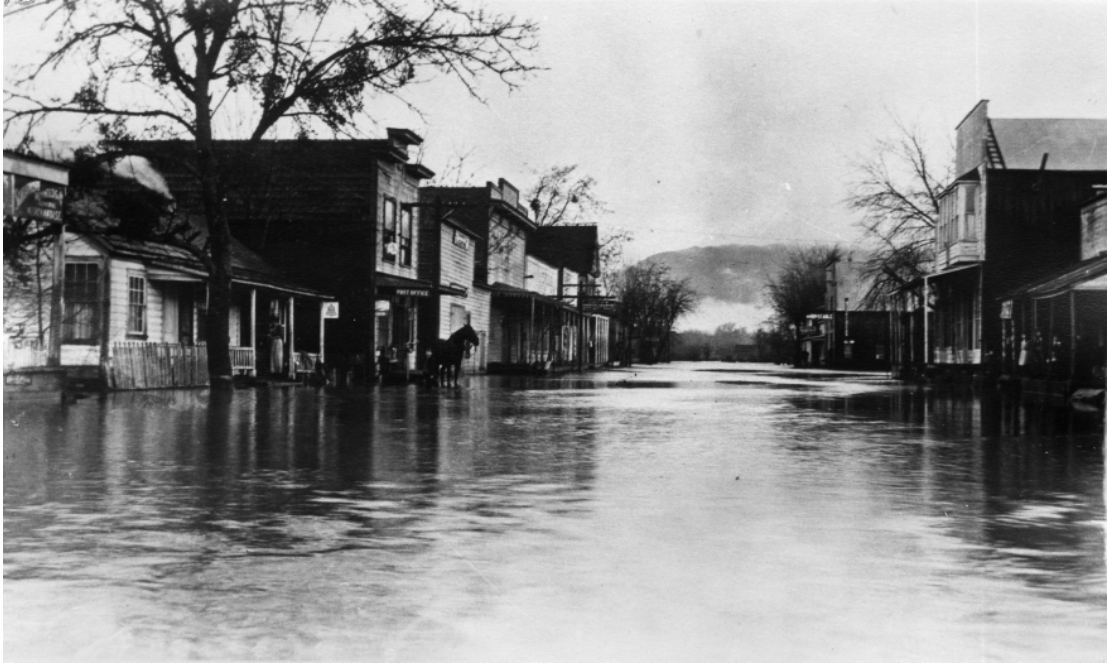
**Figure 3-1 Winter flooding in Upper Lake circa 1900.**

In the March 2008 meeting, longtime residents described changes in water resources. They remembered that Clover Creek once ran year round, and trout were present. Middle Creek also flowed year round, although it went underground in some places. Following the Fork Fire in 1996, Middle Creek ran longer than it had in previous years. Matt Hutton, a well driller along with his father, Jack Hutton, noted that static well levels have declined as much as 50 feet in some areas. Flooding was severe in Upper Lake in 1938, 1955, and 1957-58 prior to the Middle Creek Flood Control Project that improved levees in many areas to prevent flooding (Figures 3-1, 3-2).

Prior to the USACE Middle Creek Project from 1959-1966, significant flooding occurred in the town of Upper Lake on several occasions in the 1900s (Figures 3-1 and 3-2). The flood control levees built by the USACE were designed to protect the surrounding area from the 0.5% annual chance flood (200 year flood) in Middle and Clover Creeks (Figure 7-5). The design of the project has not eliminated flooding in the town of Upper Lake, however. Following the New Year's Eve flood of 2005 the lower (southern) portion of the town of Upper Lake experienced significant flooding. This flooding occurred because surface run-off from precipitation falling outside the levees backs up north of the levees where Middle Creek and the original channel of Clover Creek join. This happens when flap gates, designed to allow water coming from the north to pass through the levee and enter Middle Creek, are prevented from opening by high flows in Middle Creek. This same problem occurs in the area north of the junctions of Scotts and Middle Creeks immediately adjacent to the Middle Creek Watershed. The New Year's Eve flood of 2005 caused flood waters approximately in the vicinity of the intersection of Highway 20 and Main Street in Upper Lake.

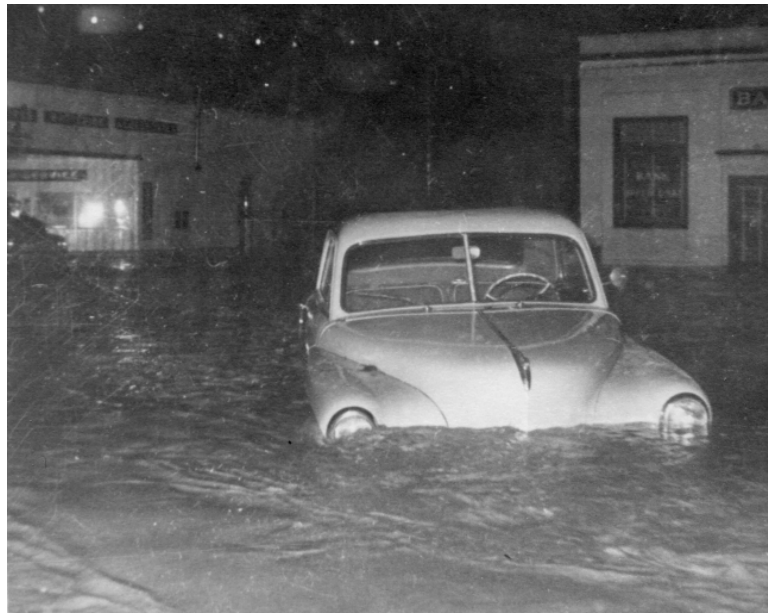
**Figure 3-2. Flooding at the corner of First and Main in Upper Lake, 1955.**

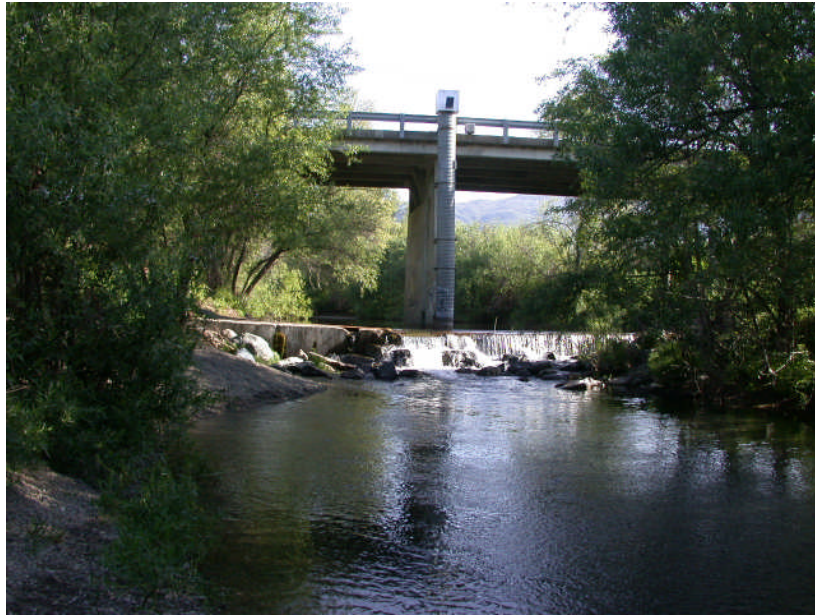
**Figure 6-1 Rancheria Bridge and the sill below, April 30, 2004.**  
*Photo courtesy of Greg Dills.*

In 2005, a series of four rock weirs were built by the Lake County Public Works Department (LCPWD) across Middle Creek below Rancheria Bridge for the purpose of improving fish passage and to stabilize streambanks. Repairs to the weirs were made following damage caused by high flows of the 2005 News Years Eve flood. The weirs are designed to create steps of no more than one foot in height once they have filled in with gravel. The weirs are designed with a lower level in the center to direct flows away from streambanks to the center of the weirs (LCWPD 2002). Although there is some concern that the weirs create a channeled and swift flow that prevents

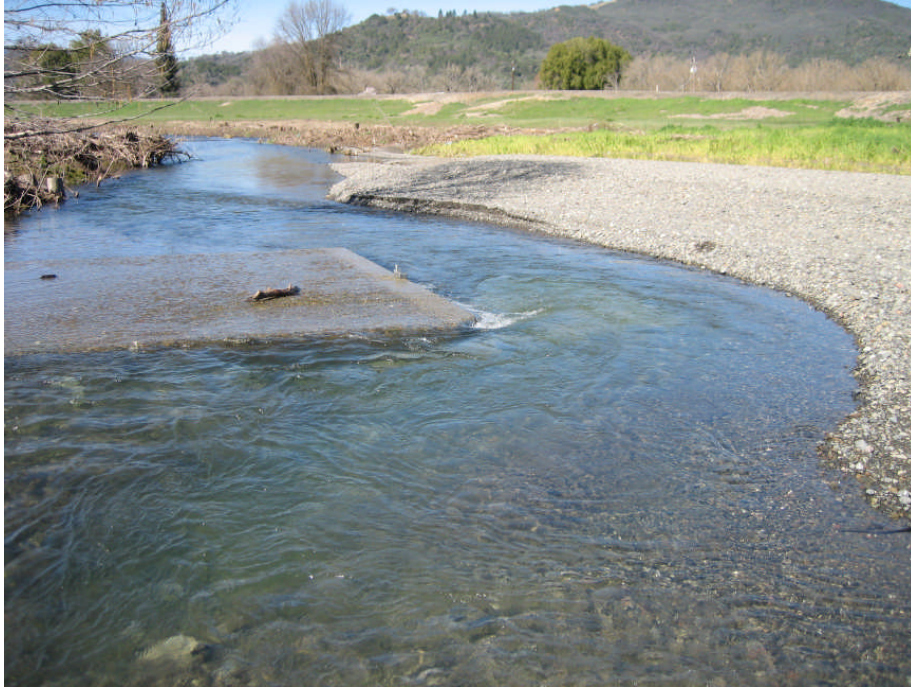
As part of the Middle Creek Flood Control Project built by the United States Army Corps of Engineers (USACE) from 1959-1966, a weir was built in the Clover Creek Diversion Channel. The purpose of the weir was to alleviate flooding during winter months and provide flows in spring and summer for groundwater recharge through the historic channel of Clover Creek in the town of Upper Lake. Because the weir created a barrier across the creek, it trapped gravel behind it that plugged the drainage culverts designed to provide base flows in the historic Clover Creek channel. The weir also created a barrier blocking passage of Clear Lake hitch. To permit fish passage and reduce annual costs for gravel and sediment removal, LCPWD modified the weir in 2007. This modification involved a 2' deep, 60' wide notch across the center of the weir ([Figure 6-2](#)).

**Figure 6-2 Clover Diversion Weir after modification and winter rains, March 4, 2008.** *Photo courtesy of LCDPW.*

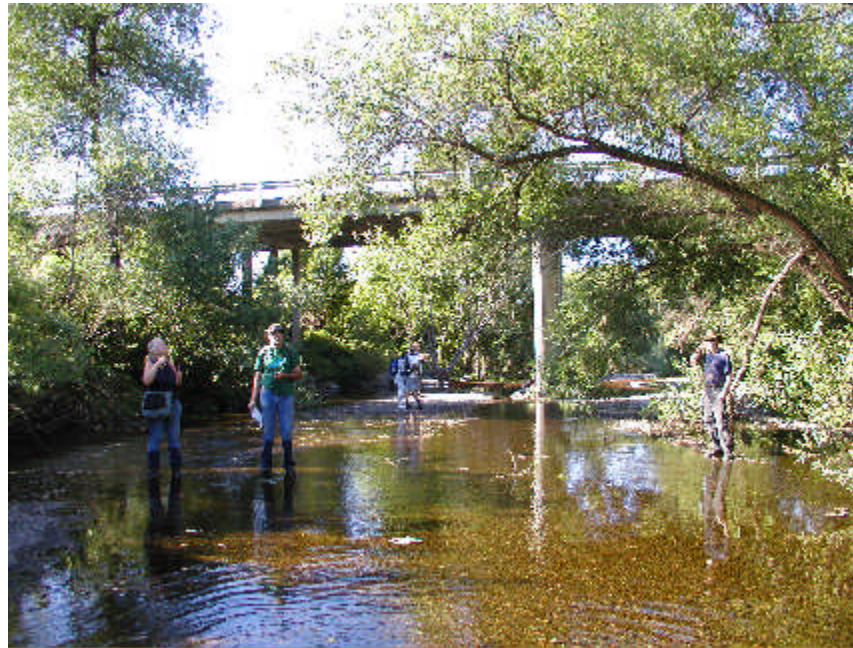
**Figure 7-4 Volunteers begin the creek survey above Rancheria Bridge on July 9, 2006.** *Photo Courtesy of Middle Creek CRMP*

The MCCRMP carried out detailed “Greenline” surveys of lower portions of Middle Creek in 2005 and 2006 (Figure 7-4), and MCCRMP member Sunny Franson wrote reports summarizing the surveys (Franson 2005, Franson 2006). Surveys were carried out in June and July of 2005, and Middle Creek was surveyed from Rancheria Bridge to Hunter Bridge and upstream of Hunter Bridge. In 2006, one survey was carried out from Rancheria Bridge to Hunter Bridge. These surveys included GPS coordinates of the area surveyed, descriptions of channel vegetation and the plant community within one kilometer, descriptions of stream bed and bank conditions, and wildlife observed. The summary of the surveys noted that very different conditions were found north and south of Hunter Bridge. The 2005 surveys documented the different plant communities along the stream channel north and south of the bridge. In addition, a greater number of bird species was observed south than north of Hunter Bridge. Bird numbers were greater south of Hunter Bridge primarily due to a colony of Cliff swallows at Rancheria Bridge.

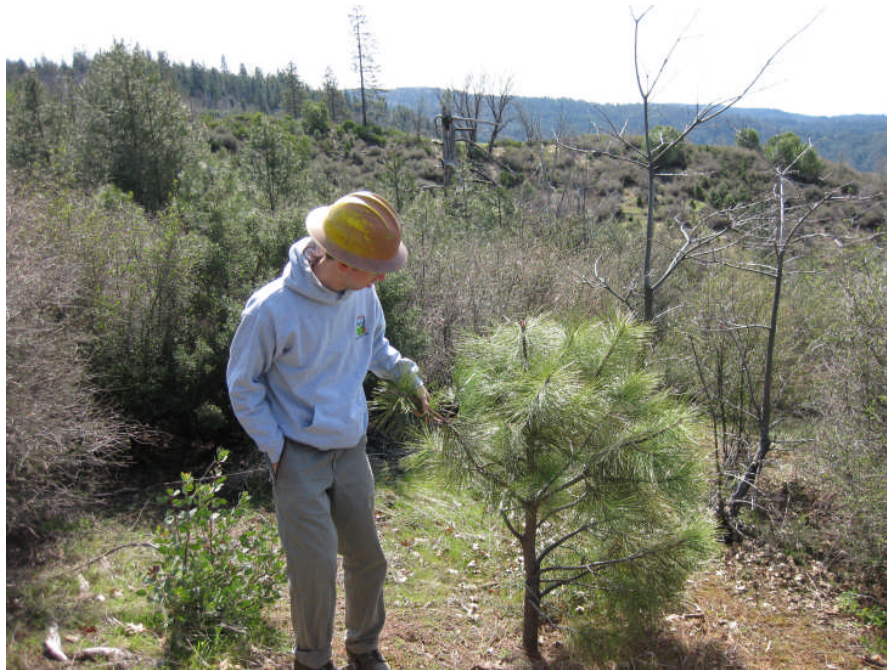
**Figure 10-2 Plantation with significant brush growth. Planted after 1996 Fork Fire.** *Photo by Greg Dills taken April 13, 2009.*

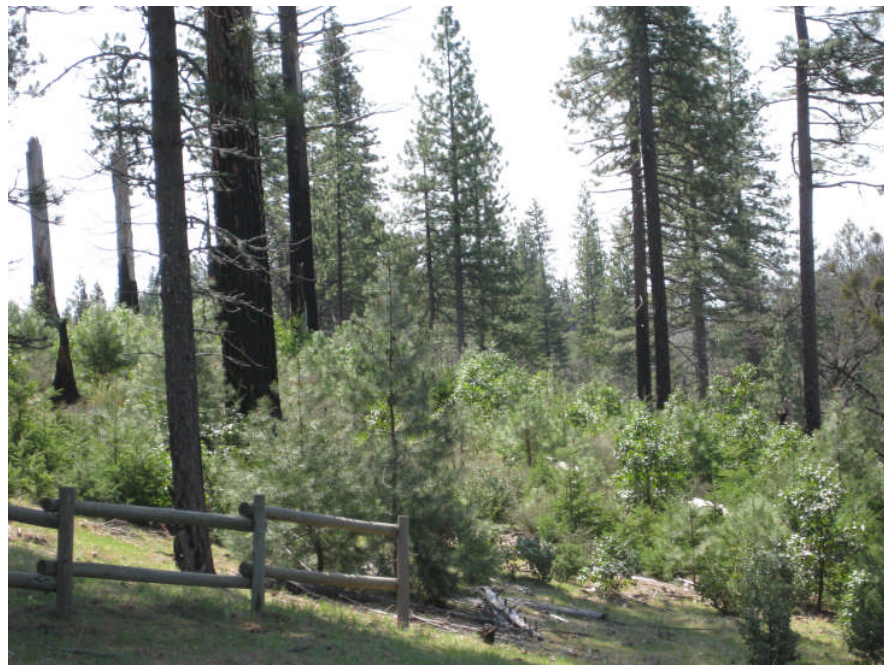
**Figure 10-3 Trees re-planted after 1996 Fork Fire. This area is at higher elevation than the previous figure.** *Photo by Greg Dills taken April 13, 2009.*

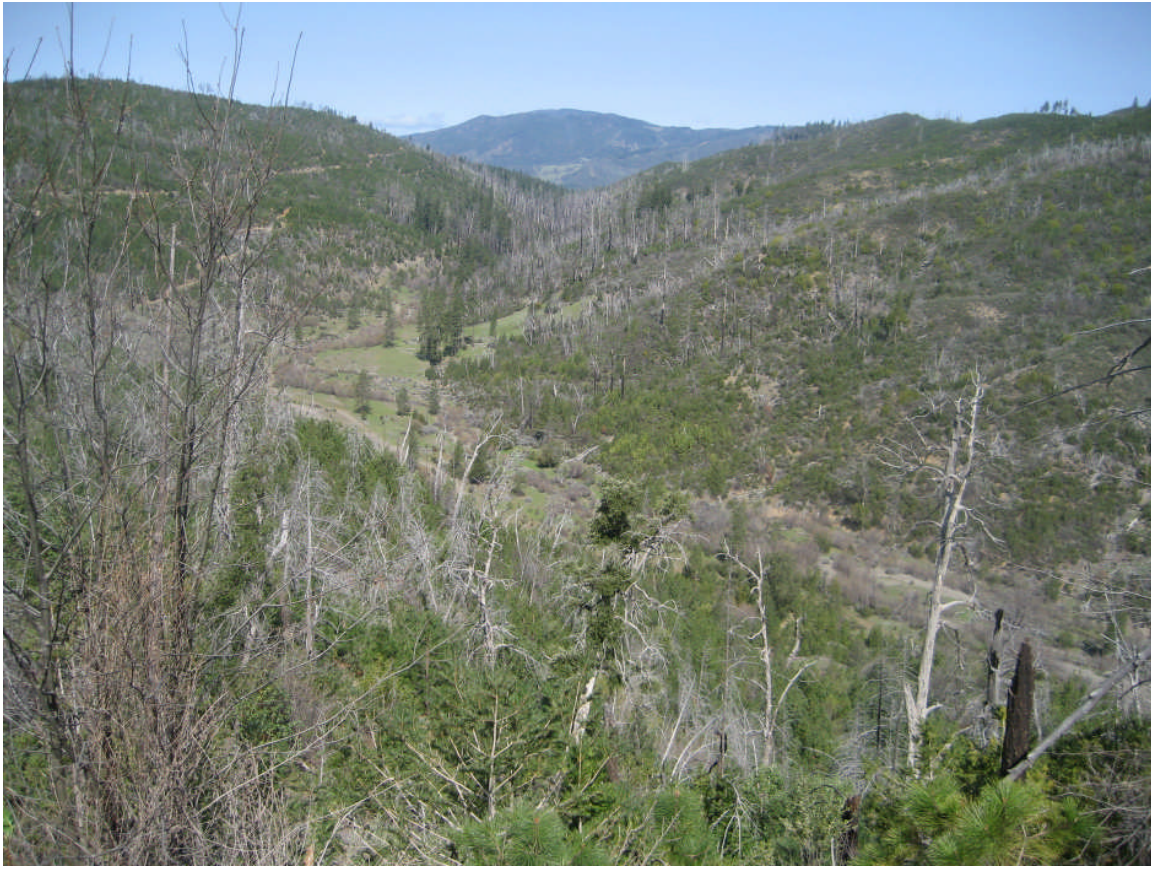
**Figure 11-1 Upper portion of east fork of Middle Creek, April 13, 2009, almost thirteen years after the Fork Fire. The clearing is Middle Creek Flat. Photo is taken looking northwest, and the creek flows from the lower right corner of the photo toward the upper middle portion of the photo.**

Much of the watershed of the east fork of Middle Creek burned during the 1996 Fork Fire. In some areas, the fire burned riparian trees, leading to reduced cover and higher water temperatures (Figure 11-1). Sediment loads to the creek increased, especially the first year after the fire. The USFS estimated that the changes in stream temperatures and siltation would affect aquatic species for at least a decade (USFS 1999).

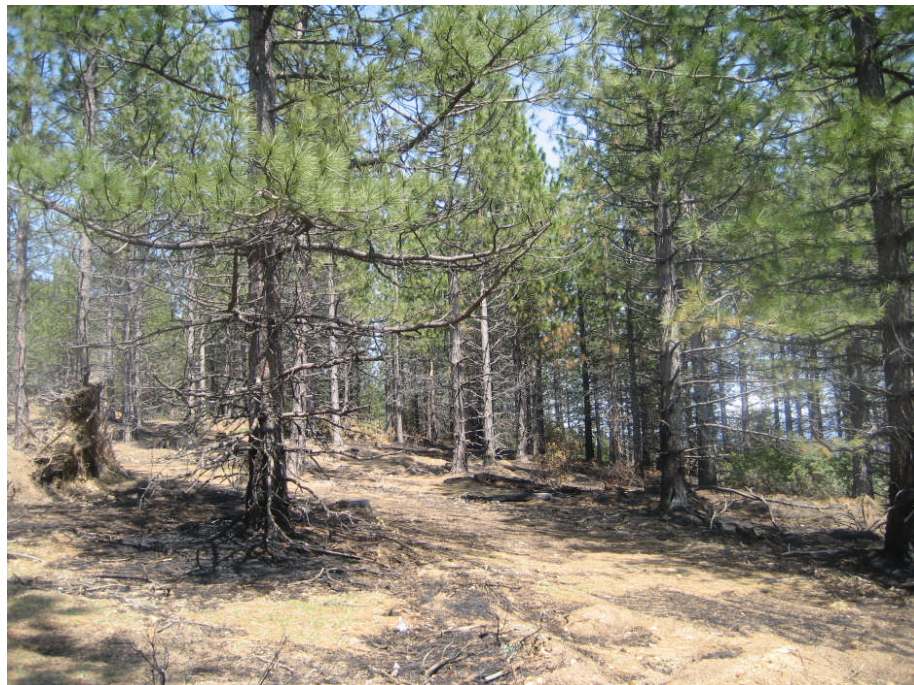
**Figure 15-1 Plantation that has recently been under-burned.**

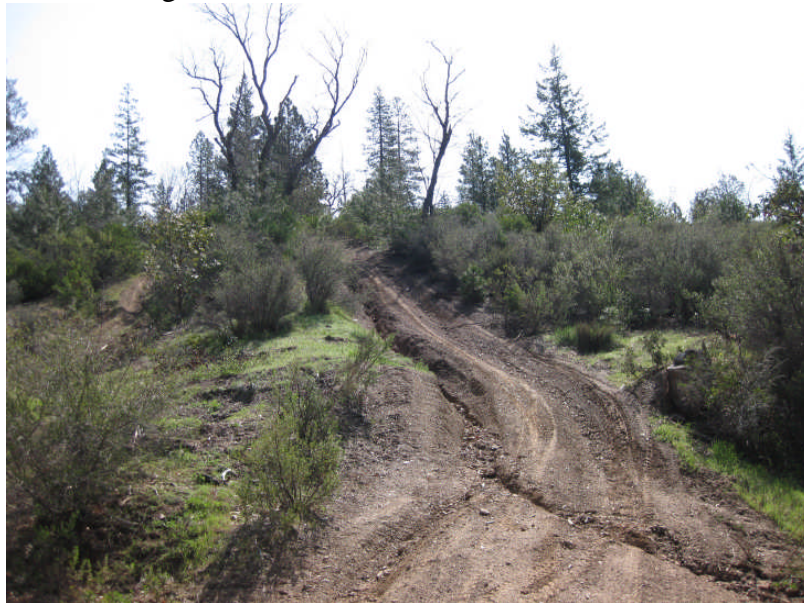
**Figure 15-2 Eroding road surface on MNF lands. (This area was burned by the 1996 Fork Fire.)** Photo by Greg Dills taken April 13, 2009.

In 2009, a MNF forest hydrologic technician inventoried road conditions, focusing on stream courses that are tributary to Middle Creek. These inventories will assist with prioritizing projects to improve road drainage and/or decommissioning. MNF is applying for FY 2010 Legacy Road Maintenance funding for some or all of the roads identified in the survey.

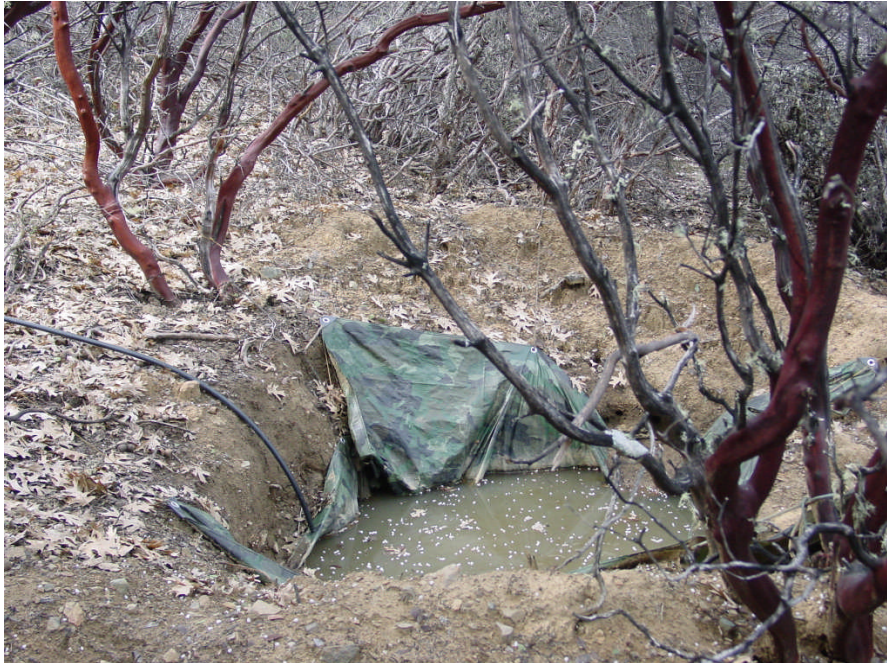
**Figure 15-3 Fertilizer mixing pond for marijuana growing located on BLM Cow Mountain land (adjacent to Middle Creek Watershed).**  
*Photo courtesy of Gary Sharpe, Ukiah BLM*

Production, (CAMP), from 2006-2008. In 2008, 500,000 plants were seized in Lake County, mostly from public lands. Marijuana growing operations frequently rely on water diversions from streams and may significantly de-water small streams during summer months. At times, ponds are built adjacent to streams for fertilizer mixing and cause both sediment and fertilizer inputs to streams ([Figure 15-3](#)). Diesel spills from generators used to power pumps or other equipment have also contaminated waterways, and trash and irrigation equipment lead to considerable clean up costs (Anderson 2008, Edmison 2007).
